Moving of the Third Office

Written by Prosecutor Investigator, Lien Yang, who also supervised construction of the Project.

Renovation Project for the Offices in the Procurement Building of Taiwan Taipei District Court Prosecutors Office
(in line with the first revision)

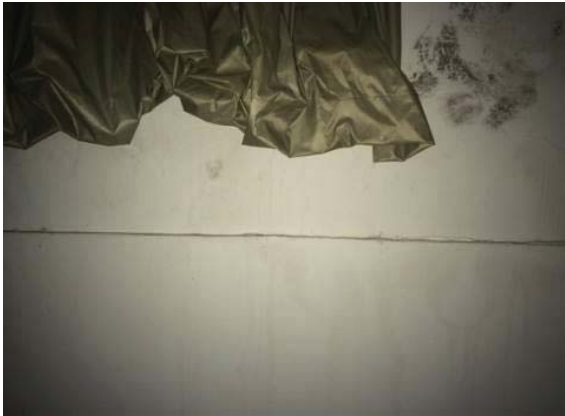
20 November 2015: window leaking condition at B1/F of Building A

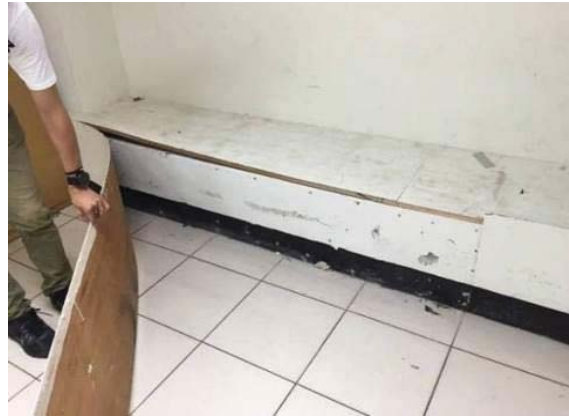
20 November 2015: current status photos of upstand beam at B1/F of Building B

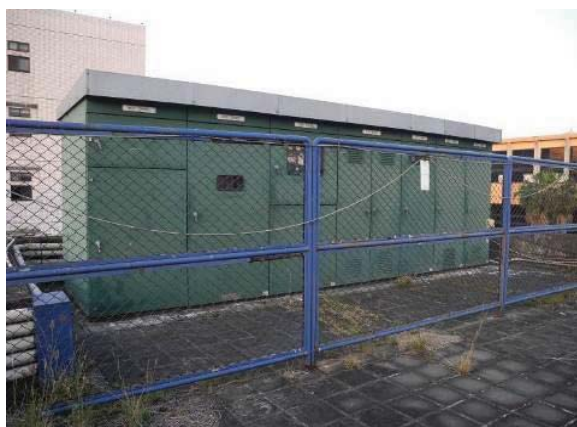
20 November 2015: 4/F, outdoor distribution box

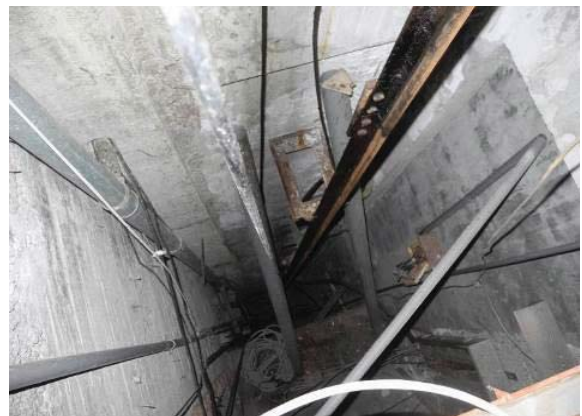
20 November 2015: 4/F, piping closet

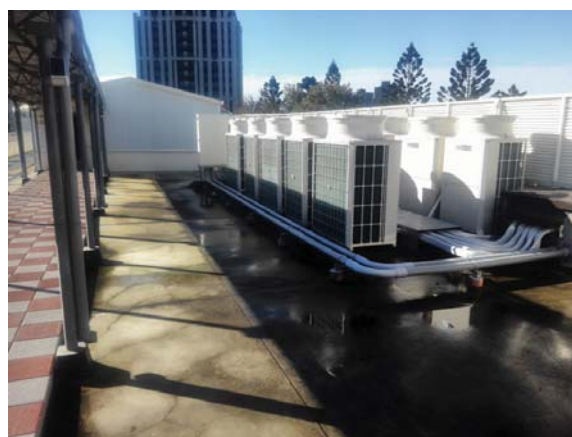
29 January 2018: 4/F, VRV air-conditioner compressor (outdoor)

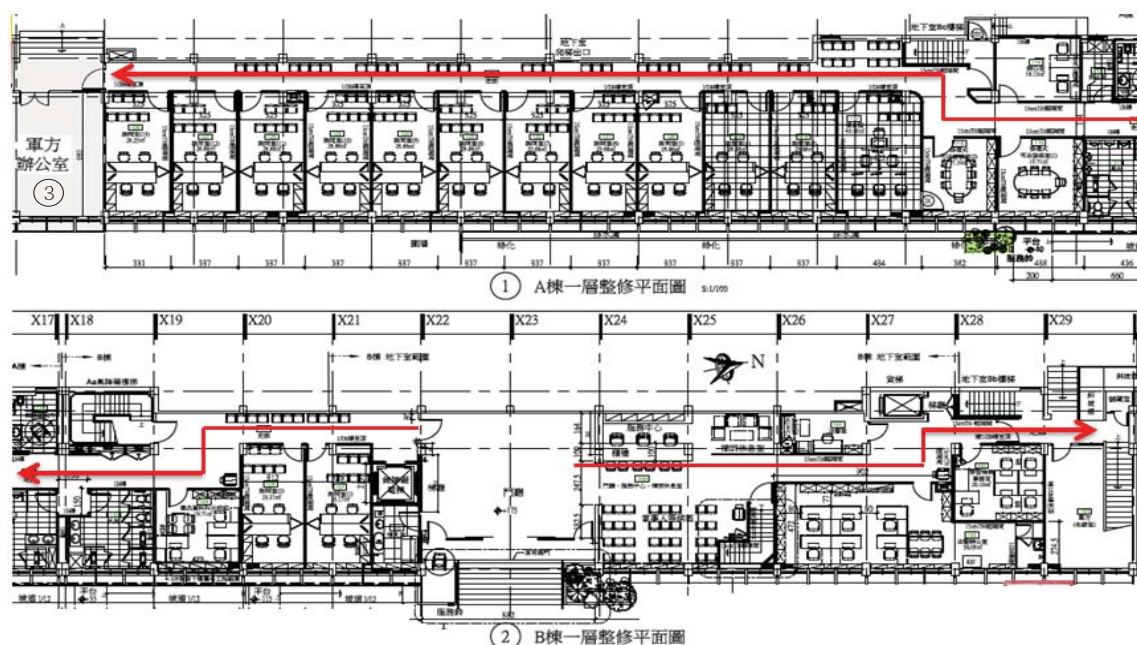
Original contracted design (prior to the change)

① Renovation Floor Plan for 1/F of Building A ② Renovation Floor Plan for 1/F of Building B ③ Military Offices

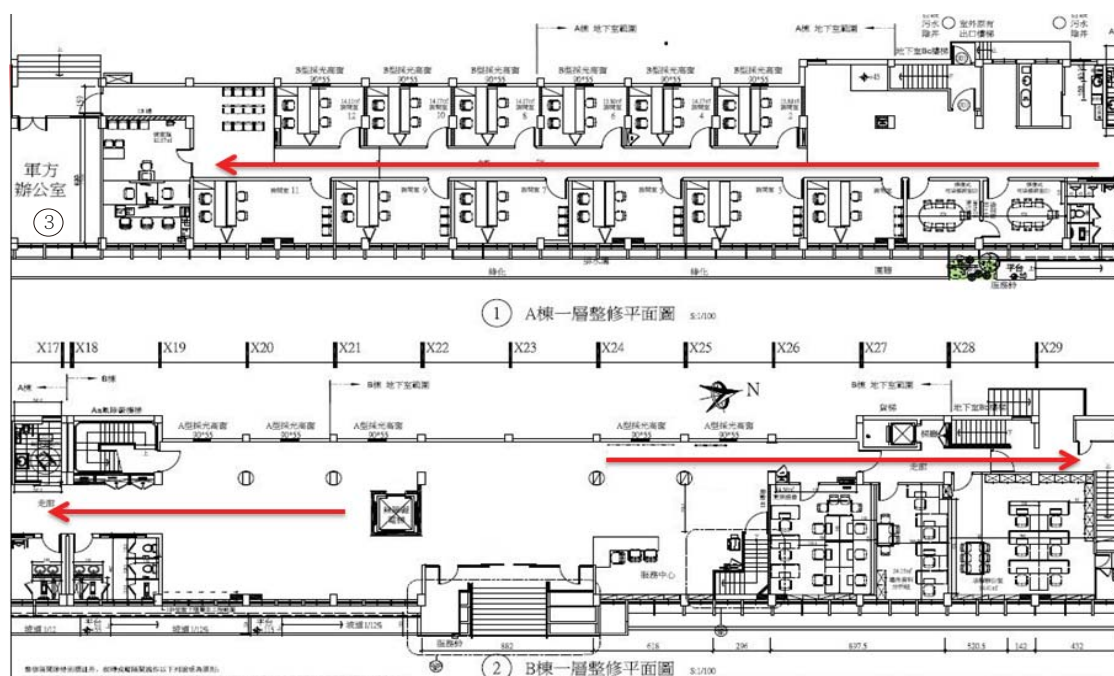
After the Chief Prosecutor made a visit on 9 May 2017, it was instructed that the circulation shall be secure without any visual blind spot (after the change)

① Renovation Floor Plan for 1/F of Building A ② Renovation Floor Plan for 1/F of Building B ③ Military Offices

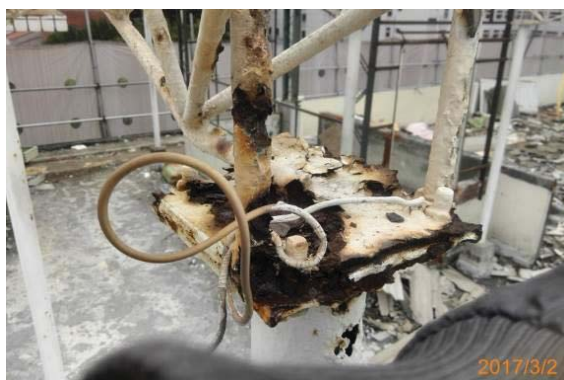
2 March 2017: rusted roof struss

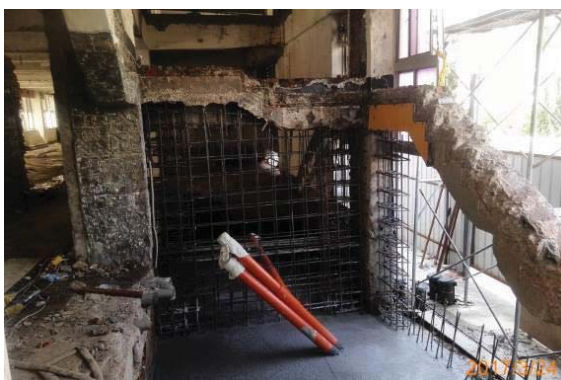
24 March 2017: demolish old staircase and rebuild new staircase

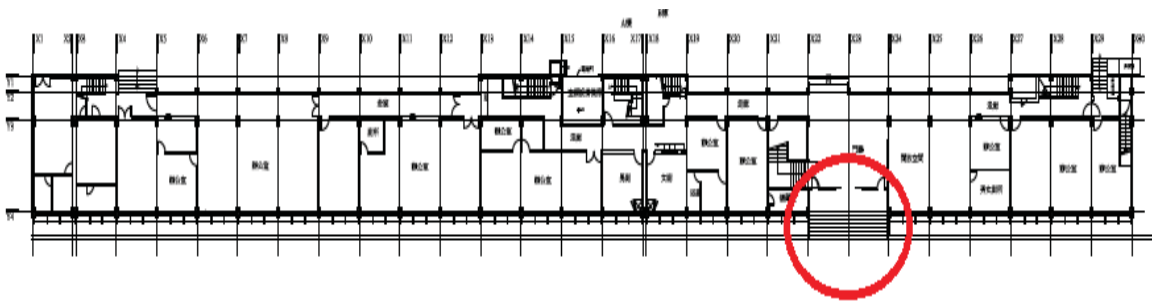
1/F existing status floor plan

- There was no original design drawing for the Project, which caused the differences between the initial design drawing and the actual construction.
- Solution: After requesting the technicians to perform on-site survey, the construction was adjusted in line with the existing status.

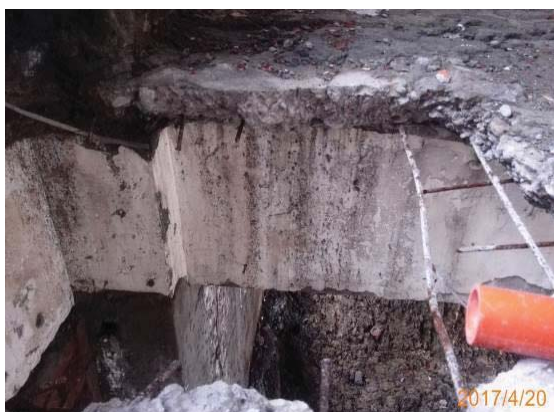
- Concrete was low in strength with poor reinforcement, the basement leak was severe
- Solution: Structural floor reinforcement applied on 2/F and 3/F
- Solution: Adopt water-conductive gravel layer, drain, catch, sewer manhole for drainage.

20 April 2017: floor slab used only single layer of No.2 reinforcement

22 May 2017: floor slab reinforcement

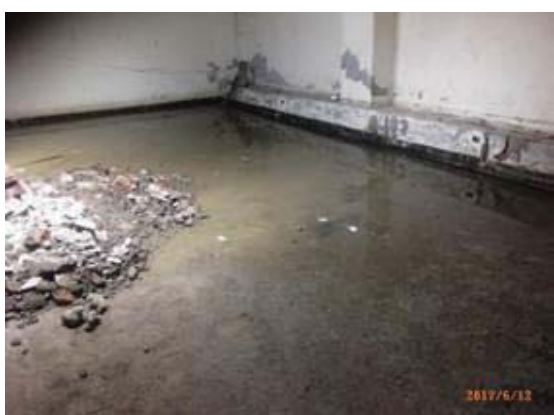
12 June 2017: the basement leak was severe

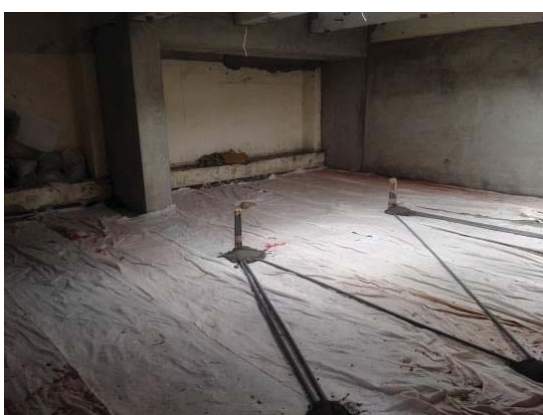
18 September 2017: drain water by crushed stone & non-woven fabric
